# CXR and CT images of Covid-19 from Singapore

College of Radiologists Singapore

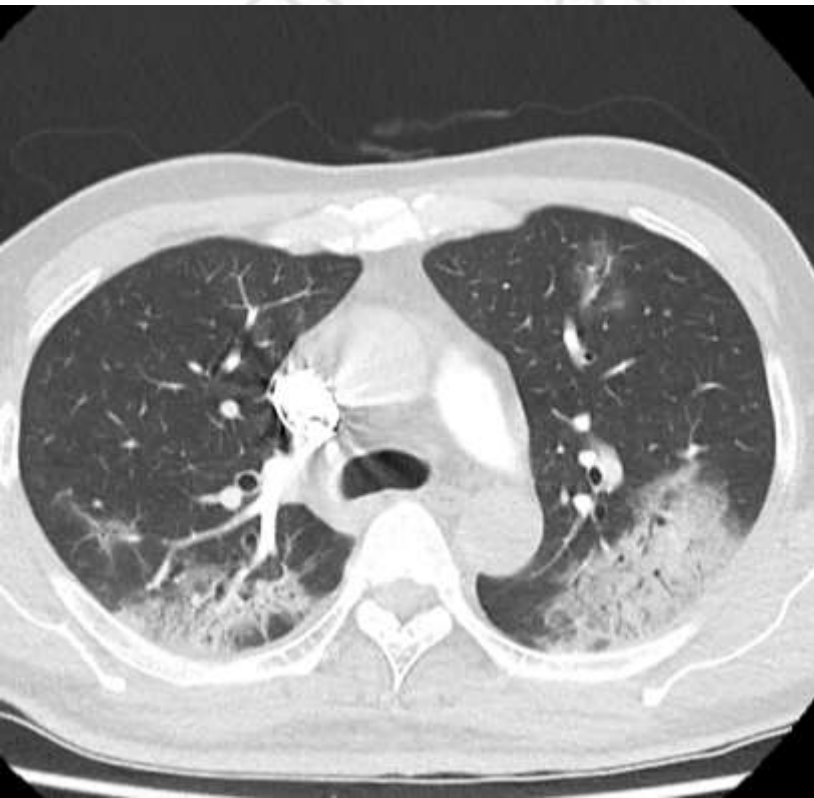
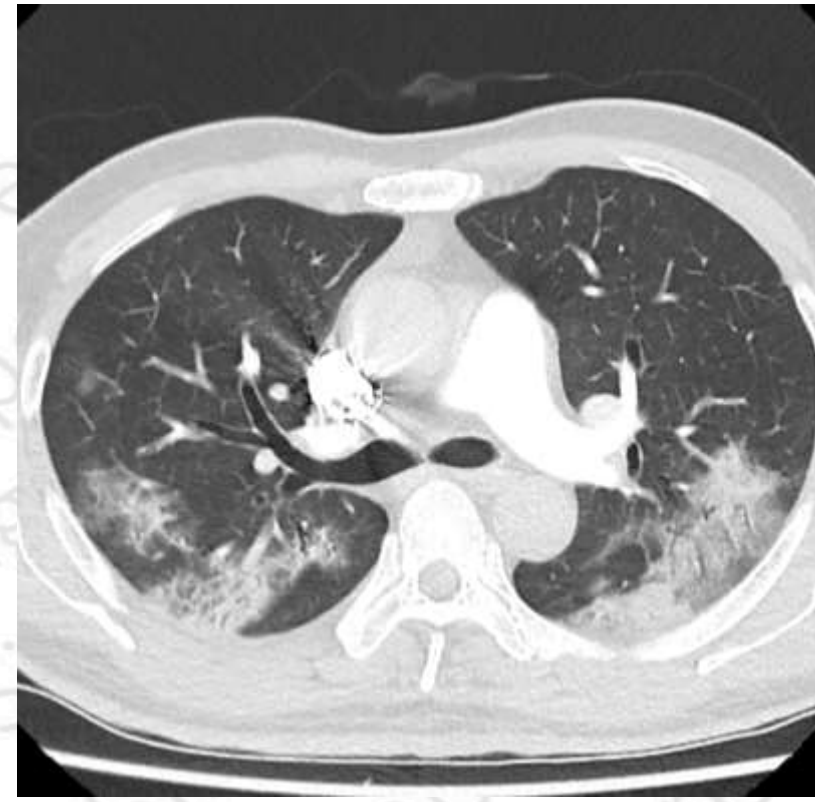
5a

**Figure 5 a-c** CT images (lung window) showing multifocal large confluent areas of pure ground glass and smaller patchy ground glass opacities which extend from a peripheral to a central location. (a-c). There is an absence of nodules and reticular opacities.

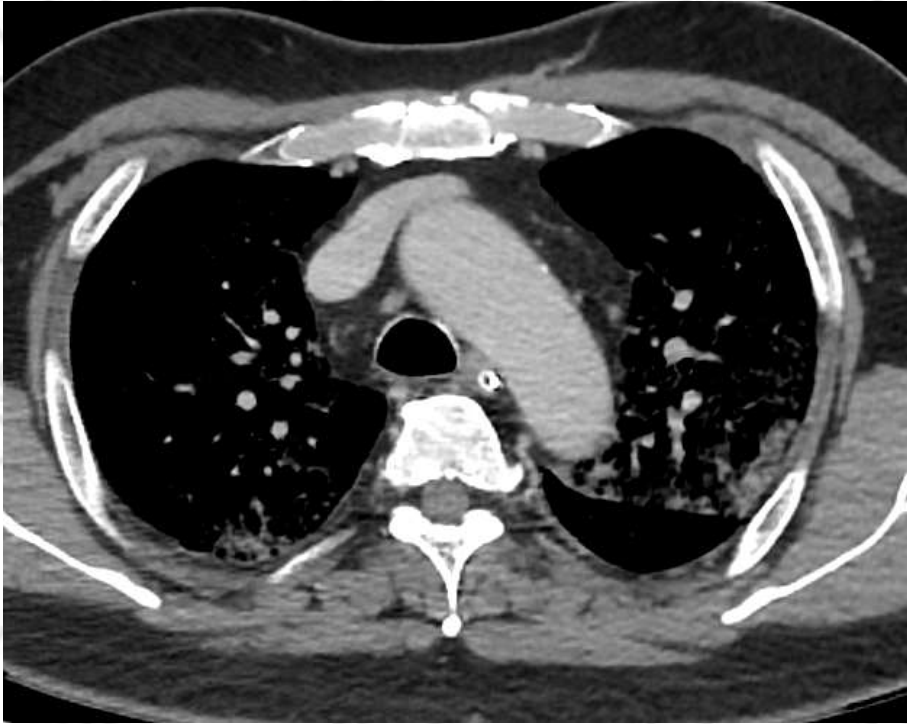
**Figure 6 a-b.** CT images (mediastinal window) showing an absence of thoracic nodal enlargement and an absence of pleural effusions (a-b).
